Inspection Report

3581 S Arizona Pl
Chandler AZ 85286

AmeriSpec Inspection Services

Date: [REDACTED]	Start Time: 08:00:00 AM Stop Time: 10:30 AM	Report ID: 060120RE14
Property: 3581 S Arizona Pl Chandler AZ 85286	Customer: [REDACTED]	Real Estate Professional: Vaught Team

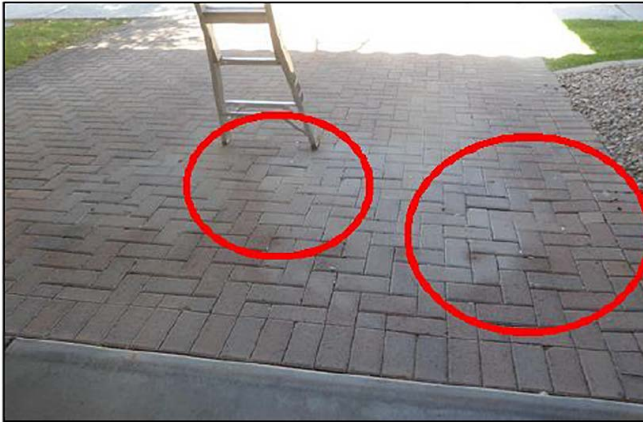
1.0 Driveways

- Observed two low points in the paver driveway. Driveway pavers tend to shift over time. Recommend continual monitoring and/or review by qualified paving professional.

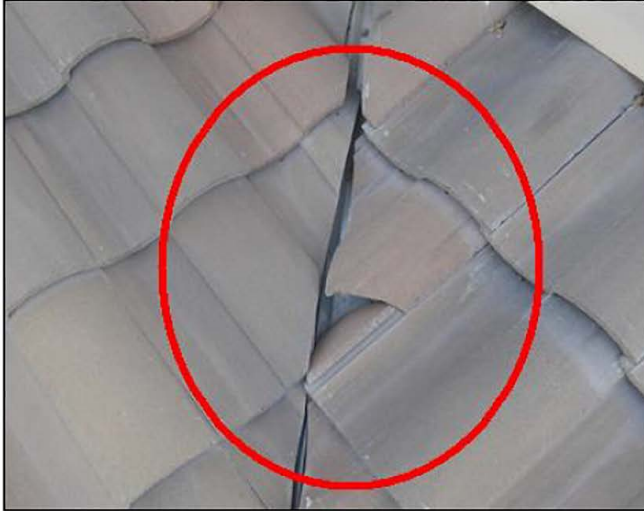
Cracked tile, front valley

»» (1) Observed two cracked tiles (one at front valley-1st level, one at rear-2nd level), end cap mud cracks, and one slipped tile (front ridge-1st level) on the roof. This could potentially allow water intrusion to the underlayment. Recommend review and repair by qualified roofing contractor.

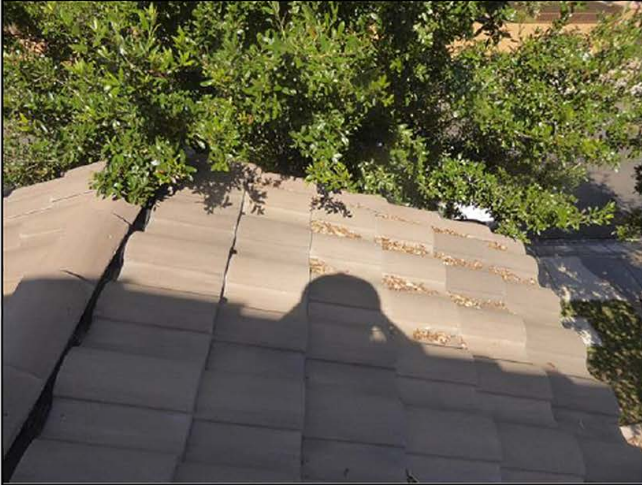
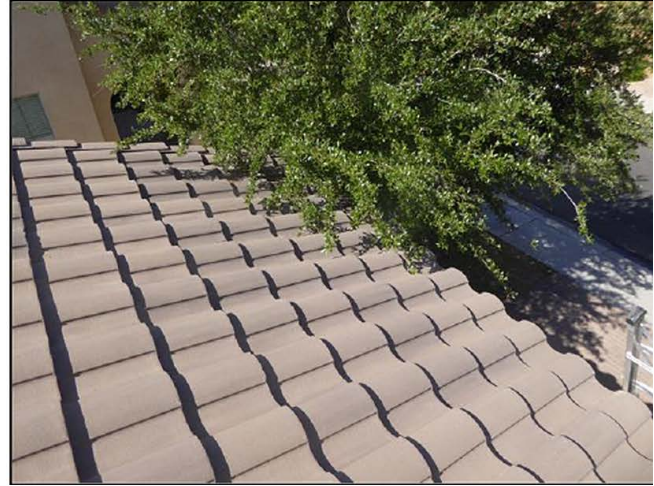
- » (2) Observed excess tree limbs in contact with the roof at the rear of the home. These should be trimmed to prevent damage. This could allow unwanted water moisture, debris and/or pest access to the roof. Recommend cutting tree limbs back to allow appropriate space to the home.

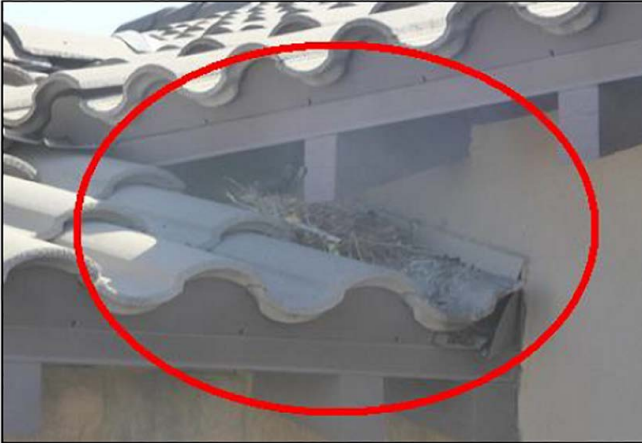
3.3 Roof Comments

- Observed bird nest debris at the front of the home. Recommend removing nest/debris to avoid potential moisture or pest intrusion to the home.

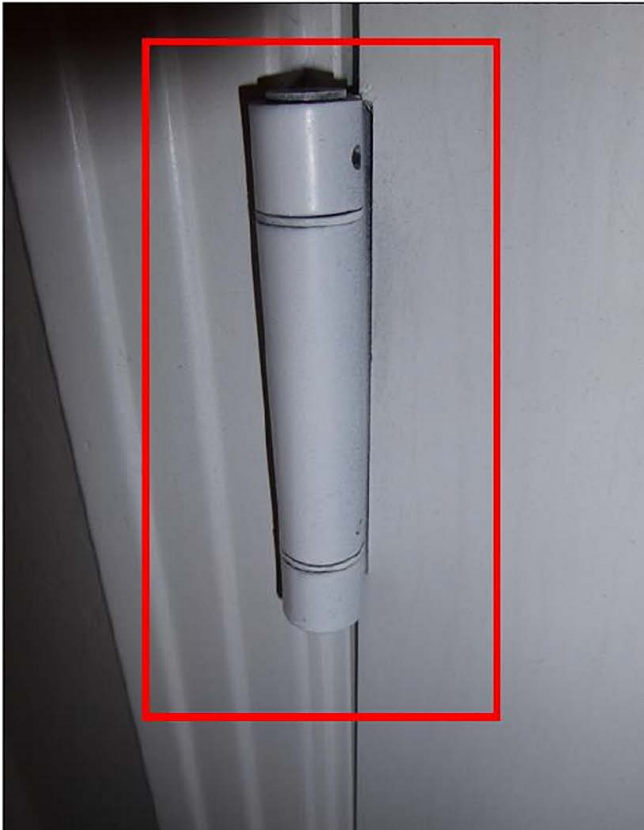
Auto-close device

- »» The self-closing device or door hardware needs adjustment or repair to properly close completely and maintain the intended fire safety of this door.

Door does not latch properly, adjustments or repairs are needed.

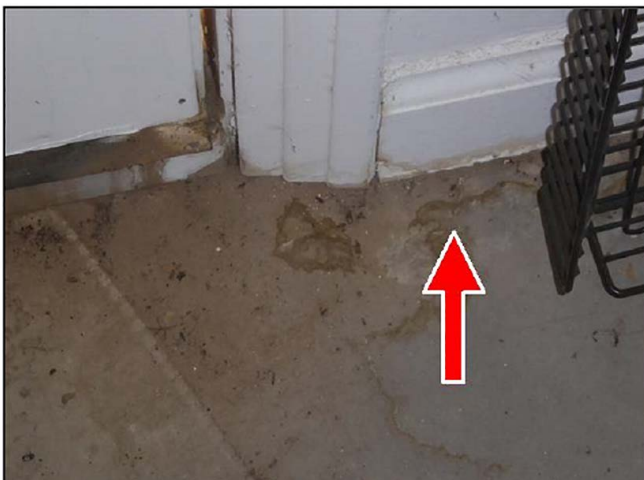
- Stains observed on baseboard at exterior occupant door in the garage. The inspector probed stains with a moisture detector, which showed no moisture present at time of inspection. Client is advised to consult seller to determine the source of staining and verify that corrections have been made.

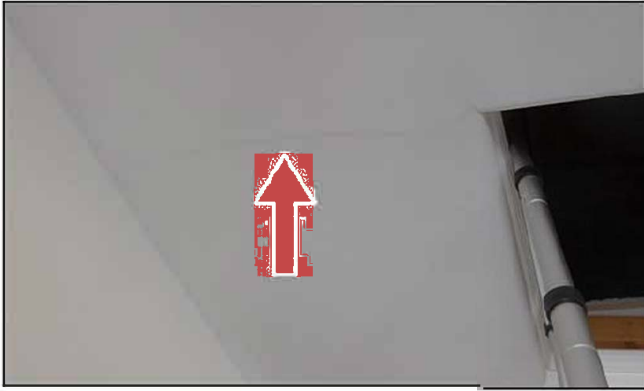
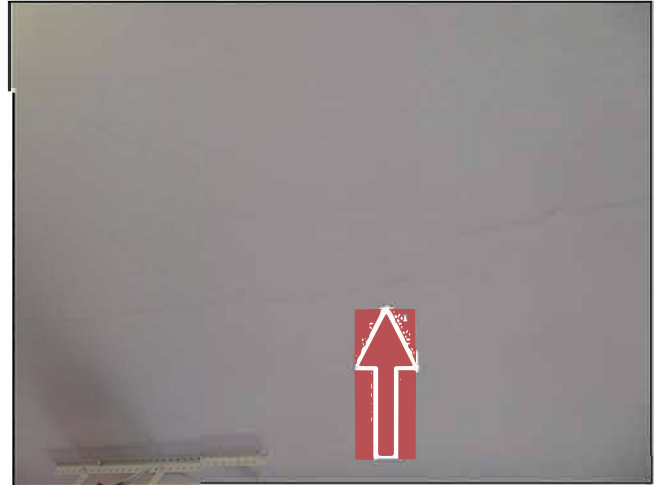
4.7 Garage/Carport Ceiling

- Common cracks noted in the garage ceiling, appears to be primarily a cosmetic issue. Recommend corrections as needed.

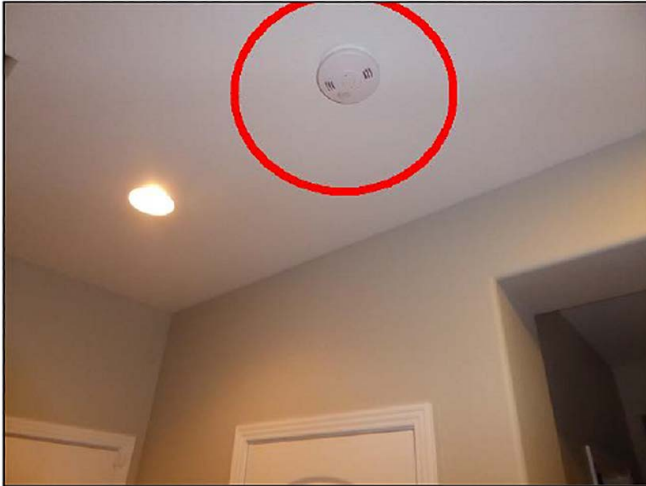
- » Observed the carbon monoxide alarm did not work appropriately when tested in the 1st floor hallway (to garage). Recommend review for corrections as a safety precaution.

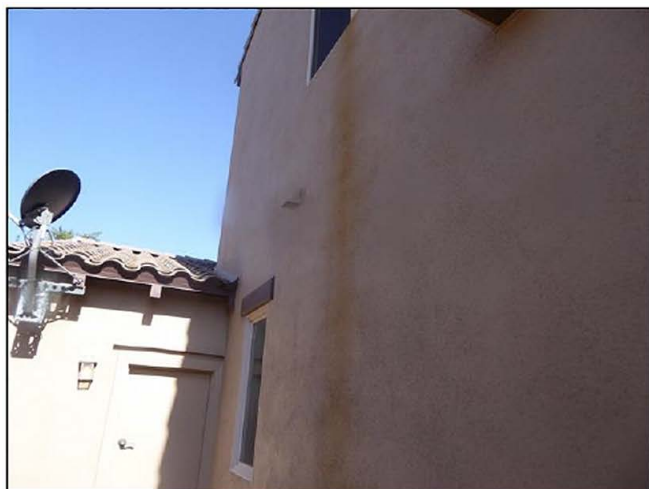
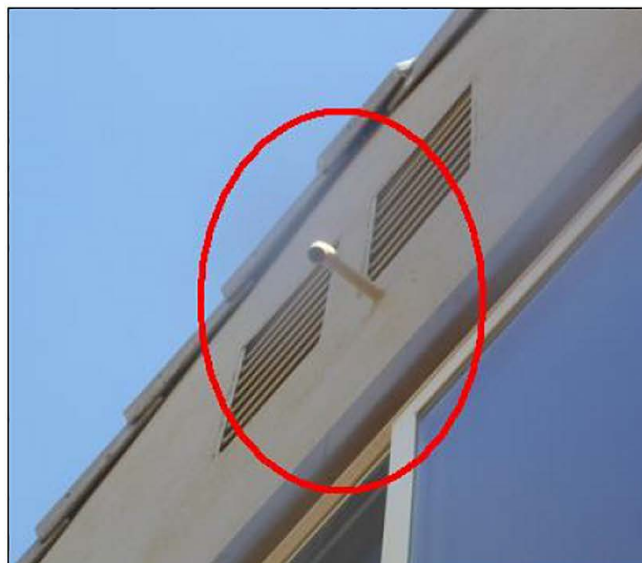
9.0 Cooling and Air Handler Equipment Condition

- »» Observed rusting stains on right side exterior wall from A/C condensation line. At time of inspection, no excessive rusting was observed in the attic condensation overflow pan. Recommend review for corrections by qualified HVAC technician to avoid further staining of exterior wall.

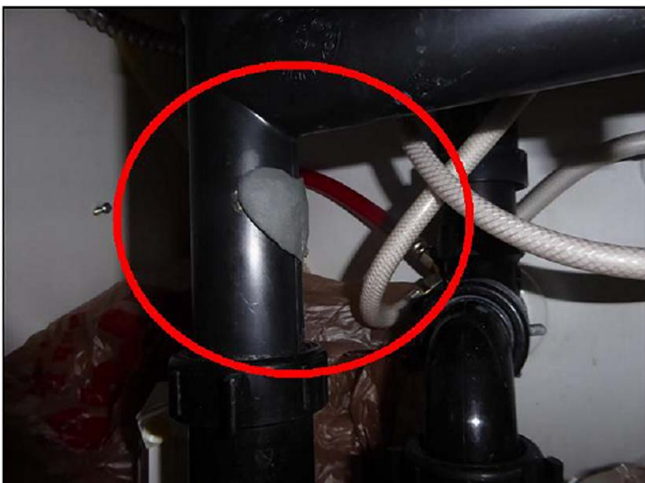
- Observed hole patched with plumbing putty on kitchen sink drain line; no leaks observed at time of inspection. Recommend review for corrections as needed.

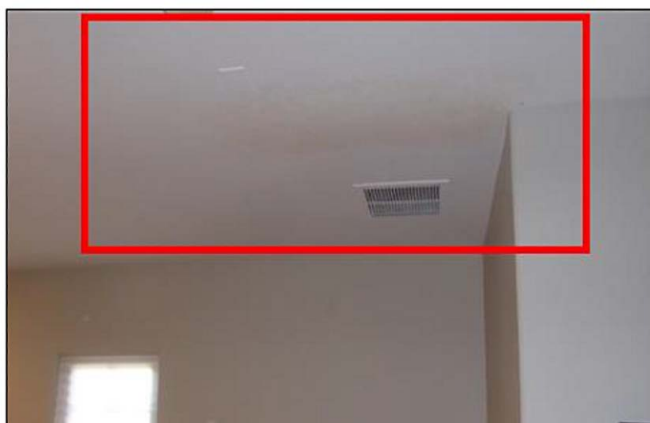
➤ Patching observed in the upstairs stairway. This may be for a common drywall cracking issue. Client is advised to consult sellers for additional information as needed.

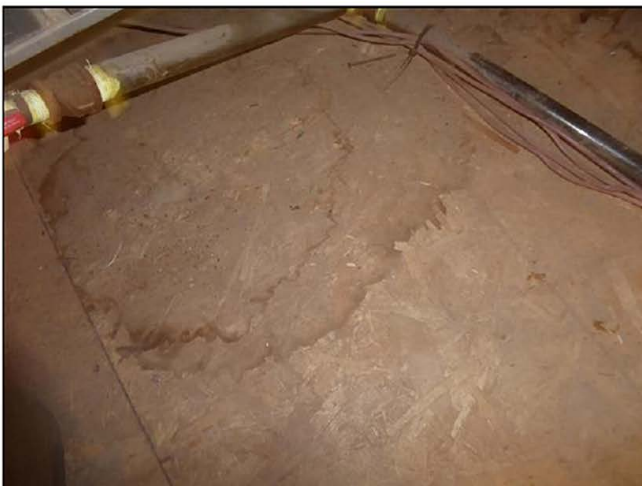
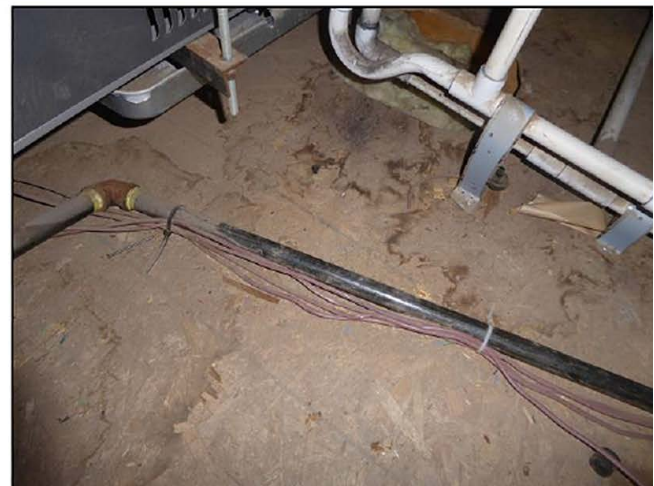
- Stains observed on attic workman's platform. The inspector probed stains with a moisture detector, which showed no moisture present at time of inspection. Client is advised to consult seller to determine the source of staining and verify that corrections have been made.

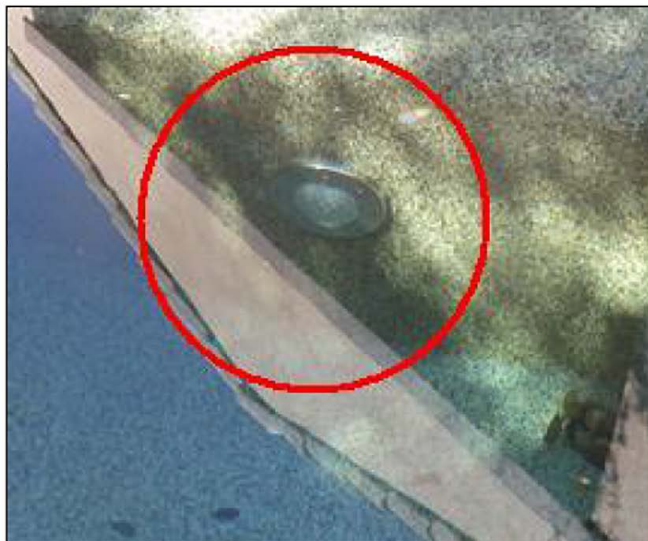
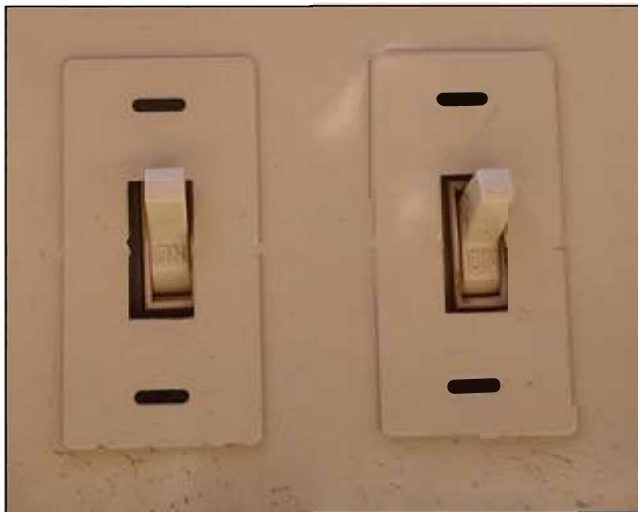
- » Spa light was inoperable at time of inspection, possibly due to burnt bulbs. Client is advised to verify operability prior to close.

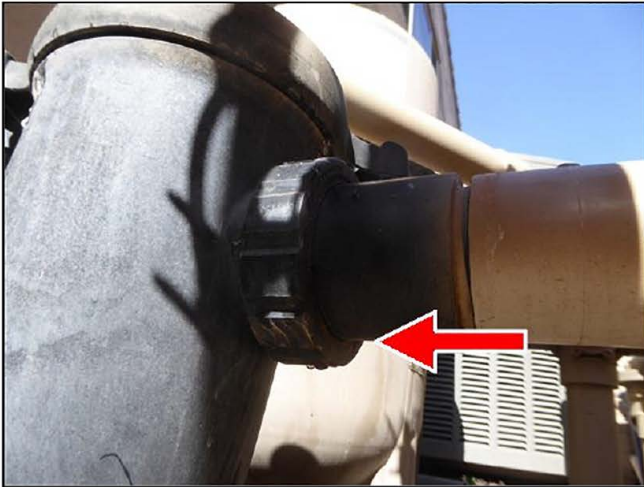
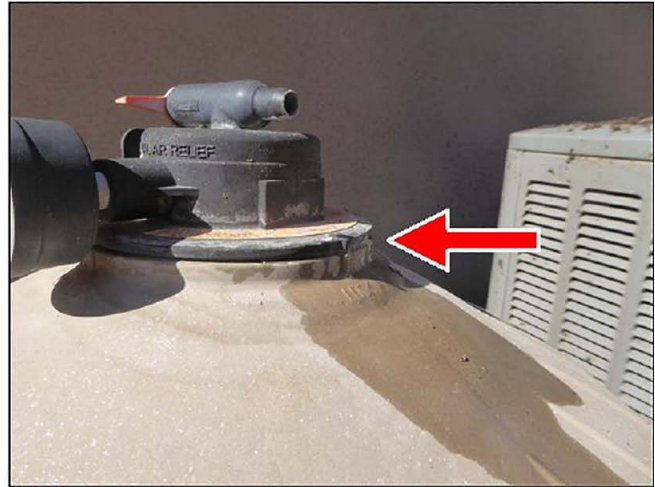
- »» Observed two small spa pipe leaks; one at connection point to pump/motor and one at top of cartridge (pressure valve). Recommend review by qualified spa specialist is needed to make all corrections needed for proper operation.

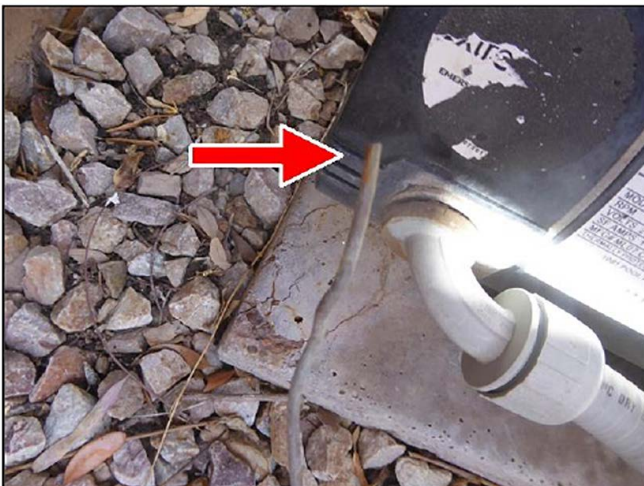
- »» Observed the spa motor has a disconnected safety bonding wire. Bonding is the process by which the electrical and metallic components of the pool are joined together with a wire to form a non-resistive path between the components. The goal of bonding is to connect, contain and prevent the transmission of any harmful electrical voltage to pool equipment, people and pets. Recommend review for corrections by qualified pool technician.

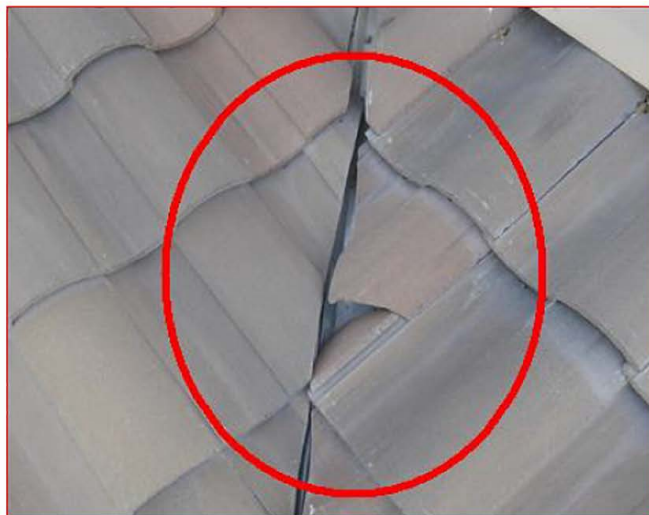
Cracked tile, front valley

- »»» (1) Observed two cracked tiles (one at front valley-1st level, one at rear-2nd level), end cap mud cracks, and one slipped tile (front ridge-1st level) on the roof. This could potentially allow water intrusion to the underlayment. Recommend review and repair by qualified roofing contractor.

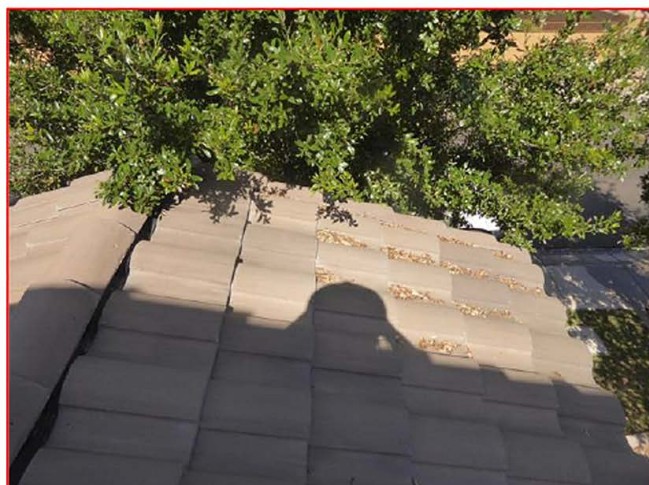
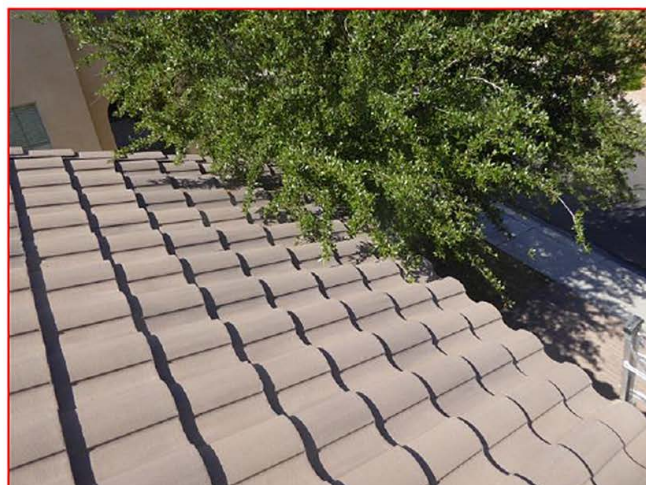
» (2) Observed excess tree limbs in contact with the roof at the rear of the home. These should be trimmed to prevent damage. This could allow unwanted water moisture, debris and/or pest access to the roof. Recommend cutting tree limbs back to allow appropriate space to the home.

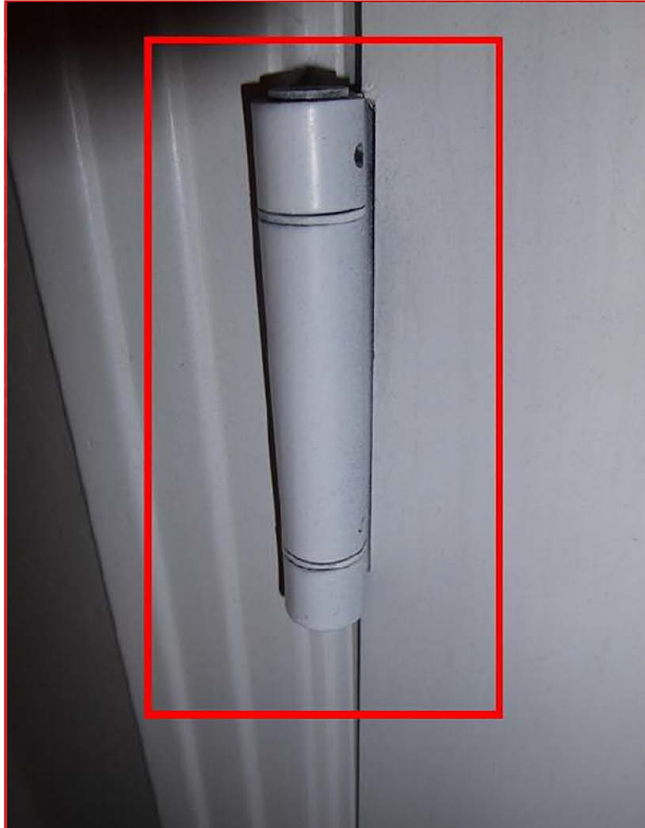
Auto-close device

- »» The self-closing device or door hardware needs adjustment or repair to properly close completely and maintain the intended fire safety of this door.

Door does not latch properly, adjustments or repairs are needed.

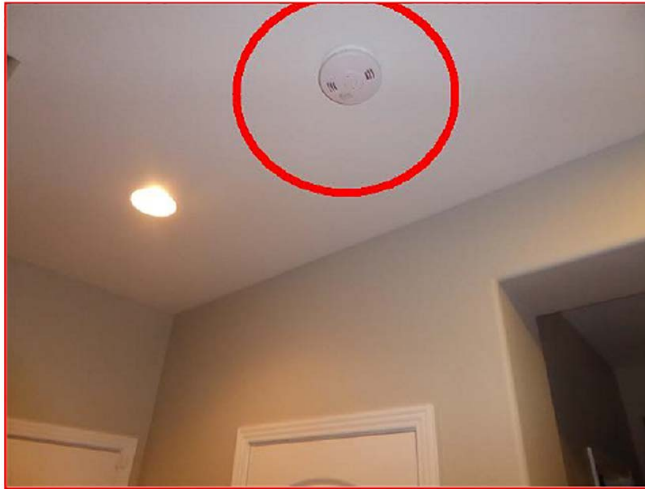
- »» Observed the carbon monoxide alarm did not work appropriately when tested in the 1st floor hallway (to garage). Recommend review for corrections as a safety precaution.

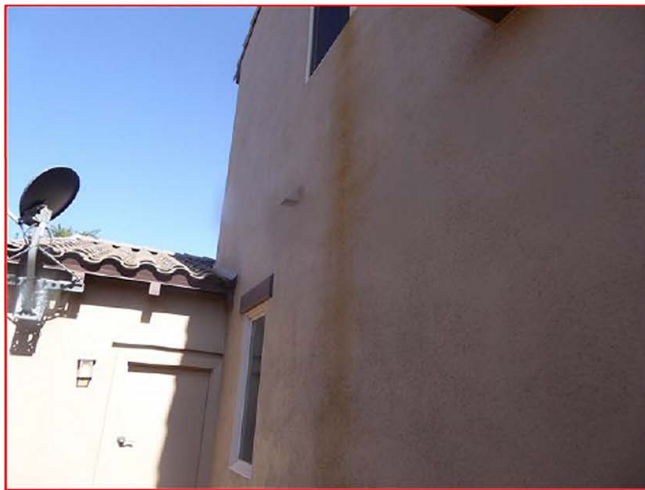
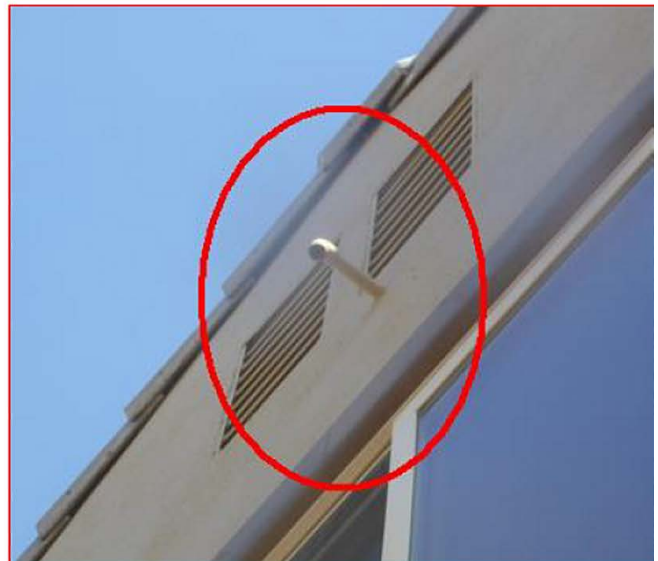
9.0 Cooling and Air Handler Equipment Condition

- » Observed rusting stains on right side exterior wall from A/C condensation line. At time of inspection, no excessive rusting was observed in the attic condensation overflow pan. Recommend review for corrections by qualified HVAC technician to avoid further staining of exterior wall.

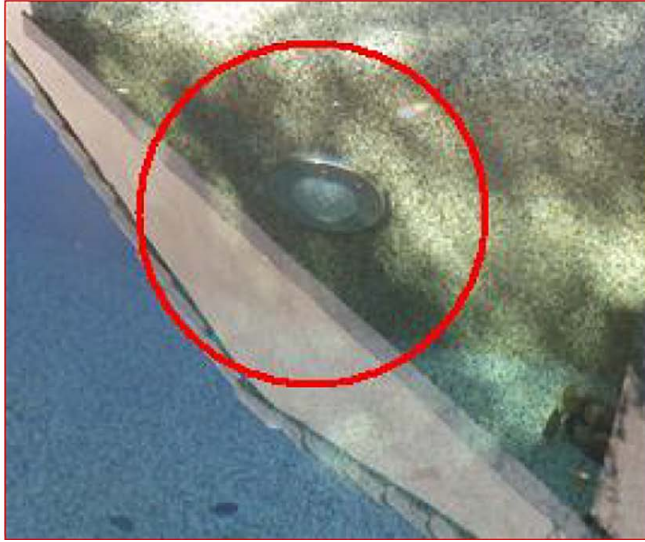
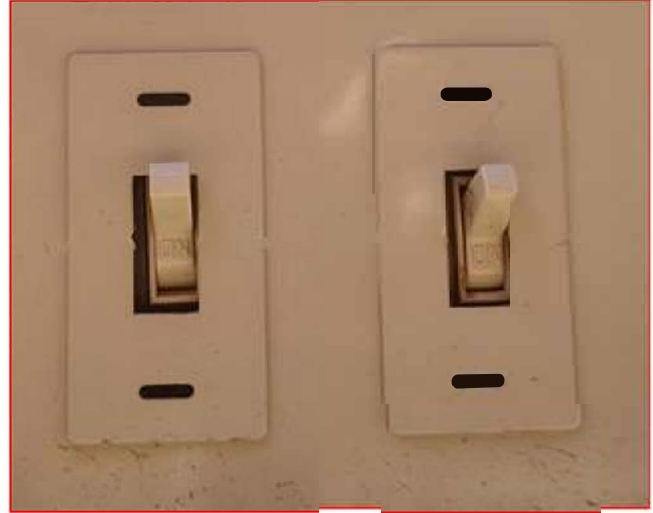
- » Spa light was inoperable at time of inspection, possibly due to burnt bulbs. Client is advised to verify operability prior to close.

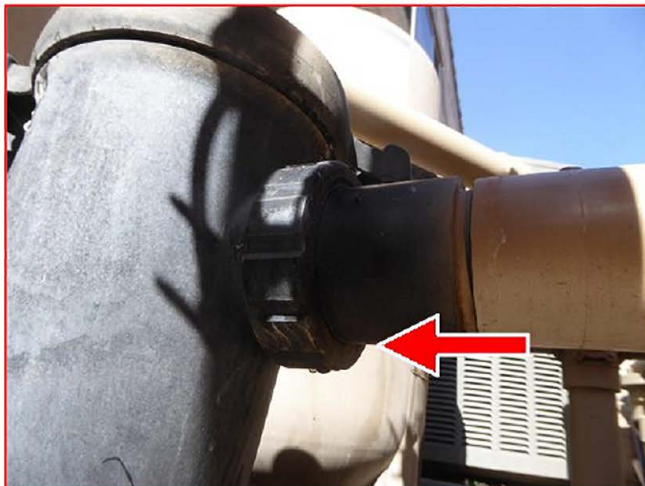
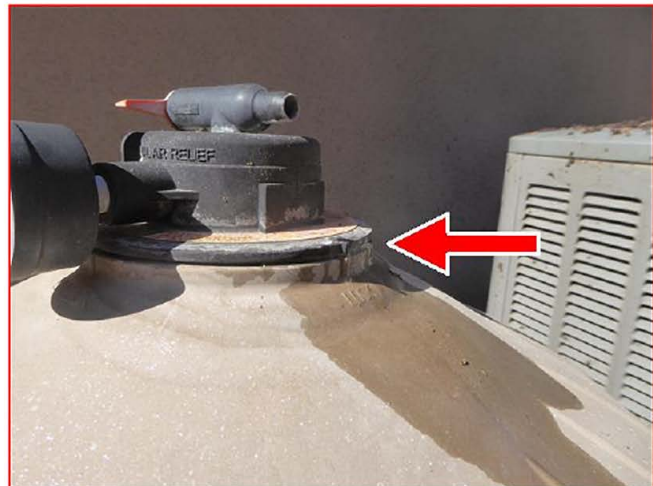
16.10 Water Supply Pipes & Connections

- Observed two small spa pipe leaks; one at connection point to pump/motor and one at top of cartridge (pressure valve). Recommend review by qualified spa specialist is needed to make all corrections needed for proper operation.

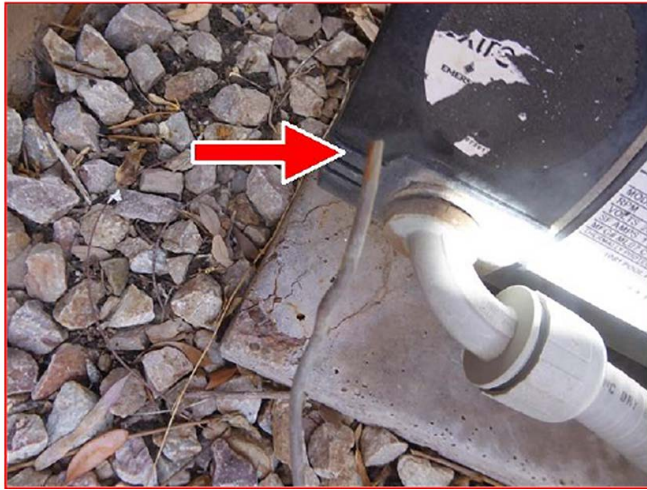
16.13 Motor

- Observed the spa motor has a disconnected safety bonding wire. Bonding is the process by which the electrical and metallic components of the pool are joined together with a wire to form a non-resistive path between the components. The goal of bonding is to connect, contain and prevent the transmission of any harmful electrical voltage to pool equipment, people and pets. Recommend review for corrections by qualified pool technician.

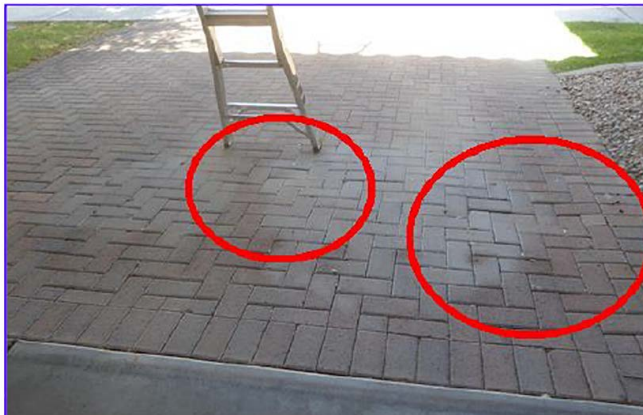
- Observed two low points in the paver driveway. Driveway pavers tend to shift over time. Recommend continual monitoring and/or review by qualified paving professional.

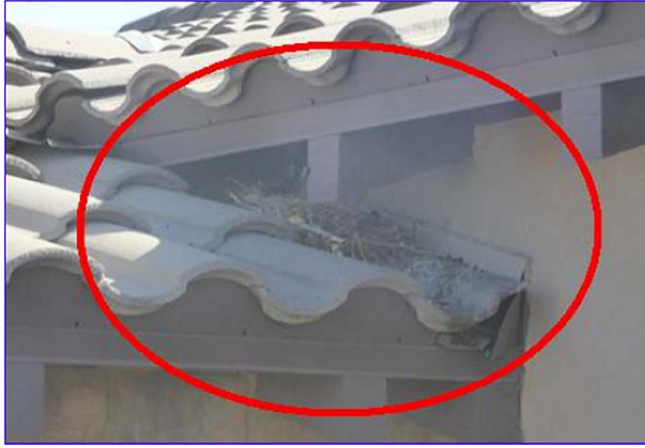
Observed bird nest debris at the front of the home. Recommend removing nest/debris to avoid potential moisture or pest intrusion to the home.

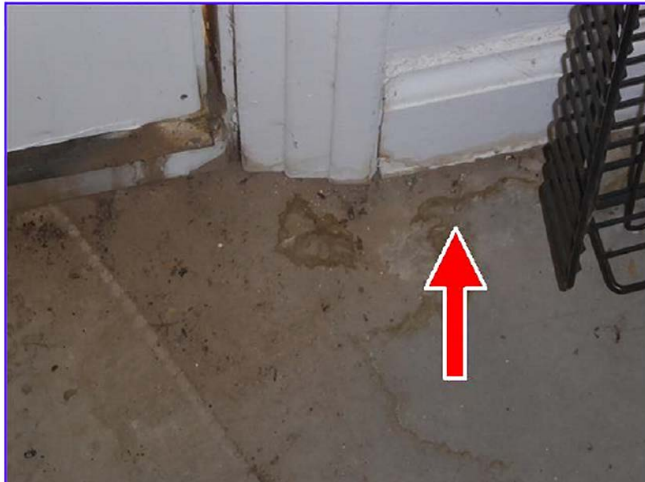
- Stains observed on baseboard at exterior occupant door in the garage. The inspector probed stains with a moisture detector, which showed no moisture present at time of inspection. Client is advised to consult seller to determine the source of staining and verify that corrections have been made.

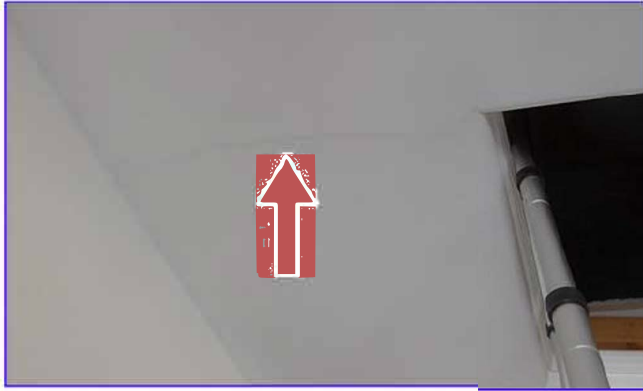
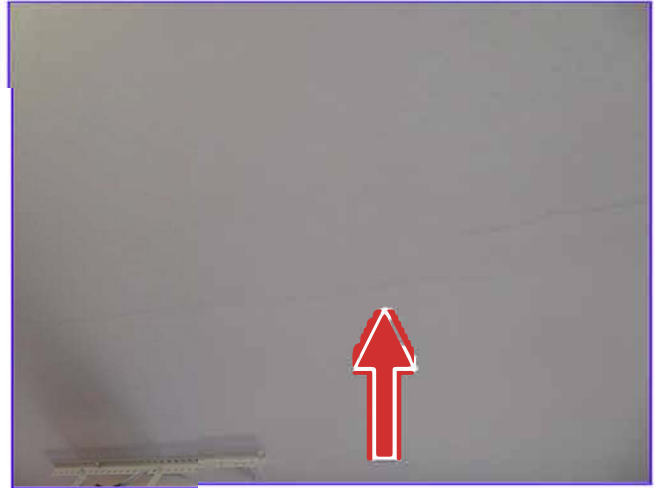
4.7 Garage/Carport Ceiling

- Common cracks noted in the garage ceiling, appears to be primarily a cosmetic issue. Recommend corrections as needed.

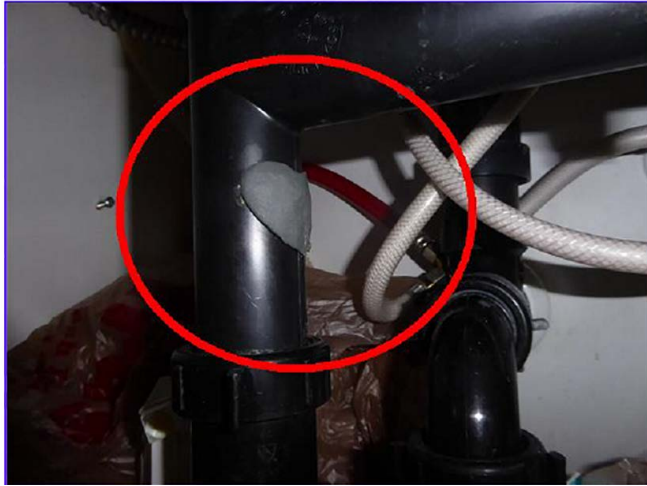
- Observed hole patched with plumbing putty on kitchen sink drain line; no leaks observed at time of inspection. Recommend review for corrections as needed.

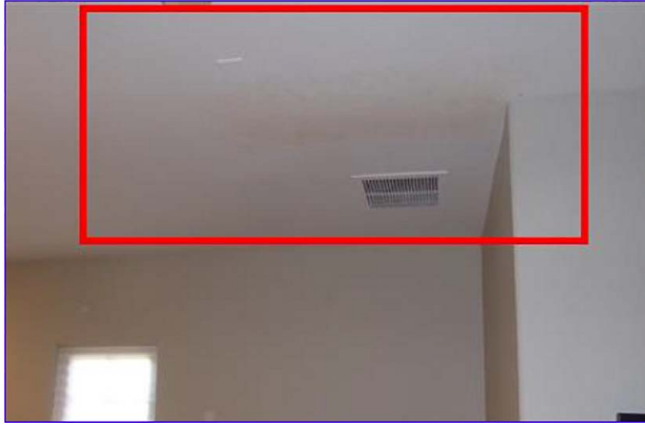
- Patching observed in the upstairs stairway. This may be for a common drywall cracking issue. Client is advised to consult sellers for additional information as needed.

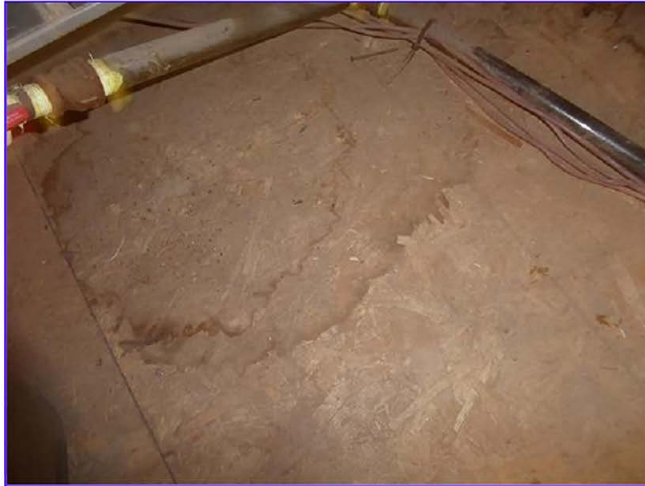
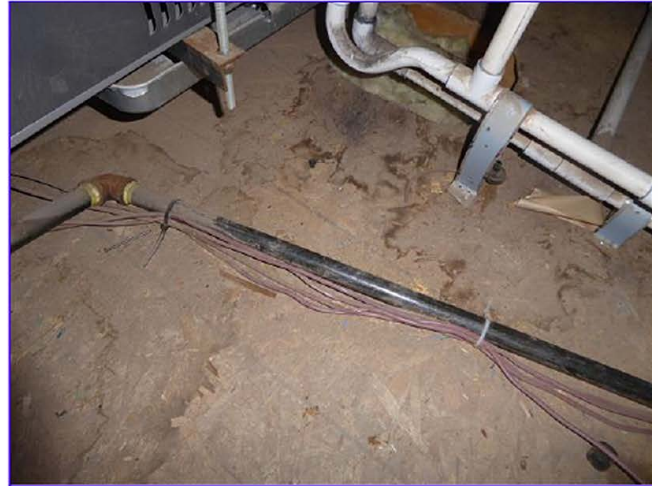
- Stains observed on attic workman's platform. The inspector probed stains with a moisture detector, which showed no moisture present at time of inspection. Client is advised to consult seller to determine the source of staining and verify that corrections have been made.
