Inspection Report

Sample Report - Older Home

AmeriSpec Inspection Services

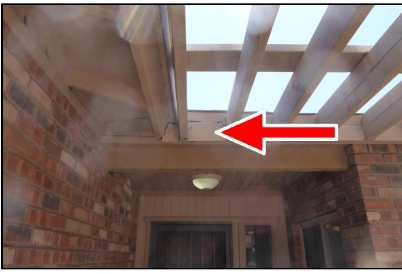
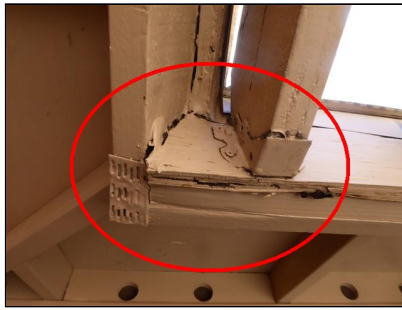
»» Damaged/deteriorated trim observed at front of home. Recommend repairs to prevent further damage.

»»» Damaged/deteriorated trim observed at front of home. Recommend repairs to prevent further damage.

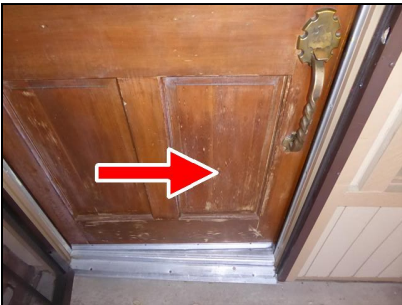
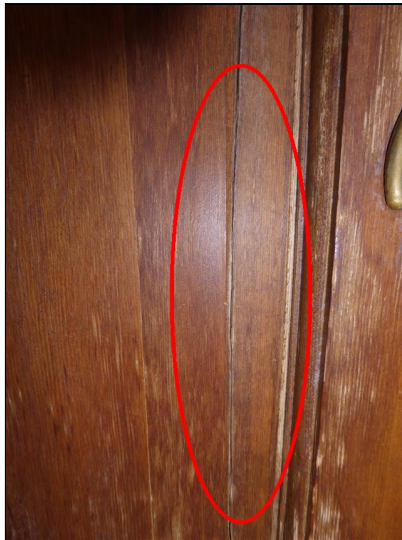
»» Damage door observed at the main entry door. Large crack at bottom of door that runs all the way through wood. Recommend review for repair or replacement as necessary.

»»» Damage door observed at the main entry door. Large crack at bottom of door that runs all the way through wood. Recommend review for repair or replacement as necessary.

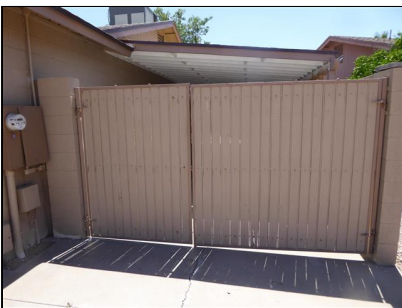
Gate locked with padlock. Unable to inspect for proper operation.

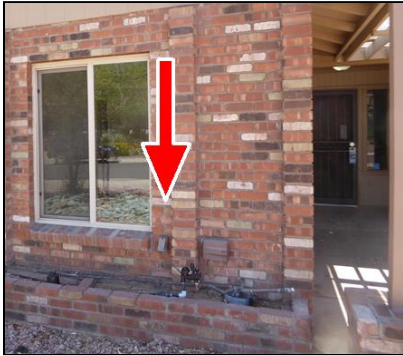
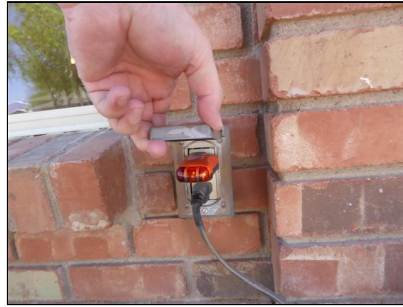
Not GFCI protected

- » (1) A Ground Fault Circuit Interrupter (GFCI) is not present in the front of home at flower bed. Suggest installing GFCI for safety by a qualified electrician as needed.

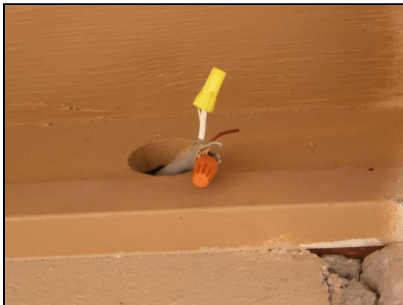
- » (2) Open wiring observed through soffit at upper-left side of house. This could be a safety issue. Recommend review and repair by qualified electrician.

»»» (2) Open wiring observed through soffit at upper-left side of house. This could be a safety issue. Recommend review and repair by qualified electrician.

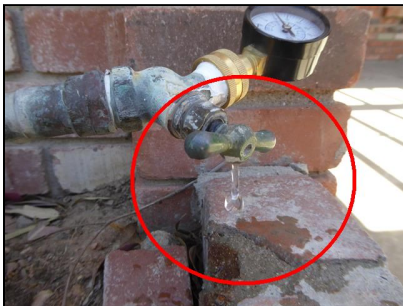
- » Stem packing leak observed at front of home exterior faucet, recommend review for repairs as needed.

»»» Stem packing leak observed at front of home exterior faucet, recommend review for repairs as needed.

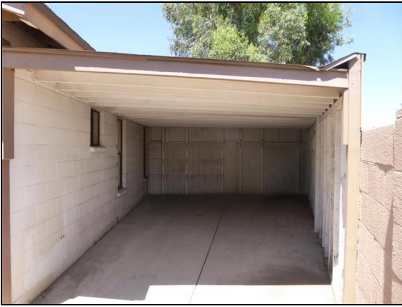
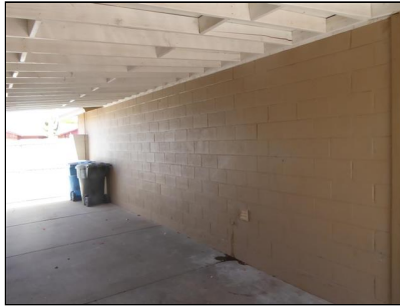
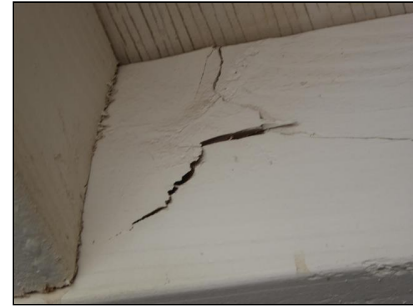
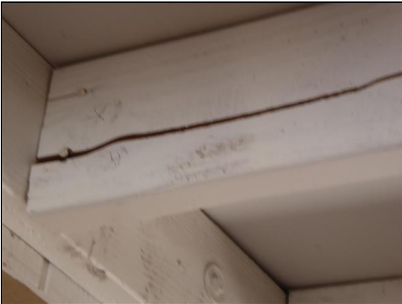
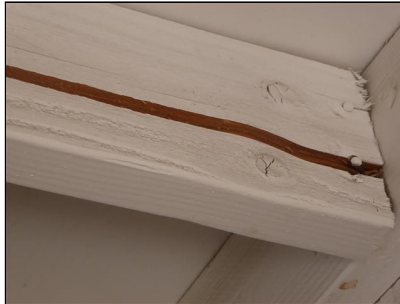
- »» (1) Inspected two built on shed areas on each side of home. These units are built on or next to the property's block fencing. Observed several cracked roofing rafters in both units. Roof sheathing is warped, broken or missing in several areas on both units. Recommend review and repair by professional, as needed.

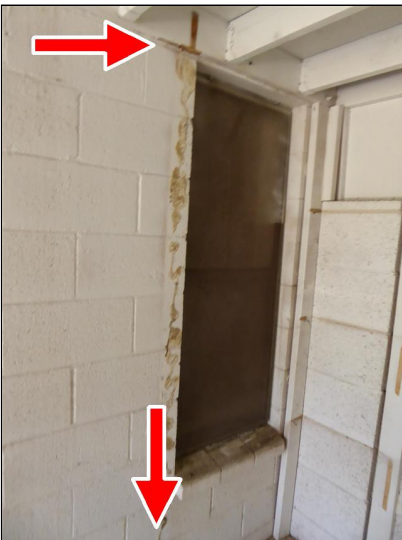
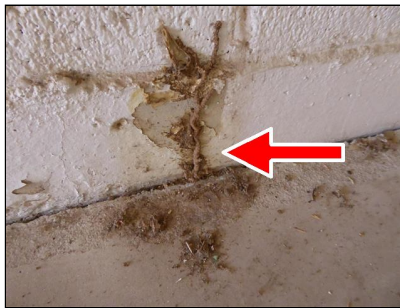
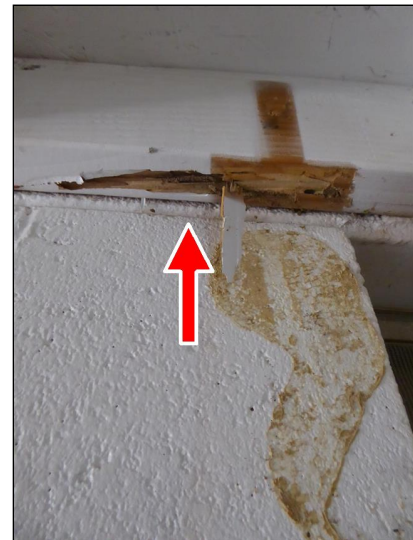
East Side of home - under shed area

- »» (2) Observed signs of pest trail and tubing on east side of house. Recommend review and treat by a qualified pest control person.

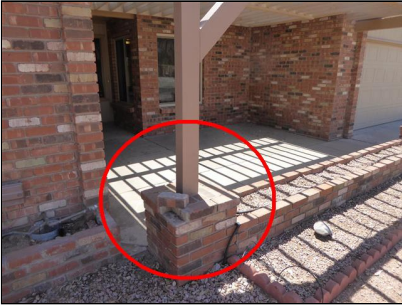
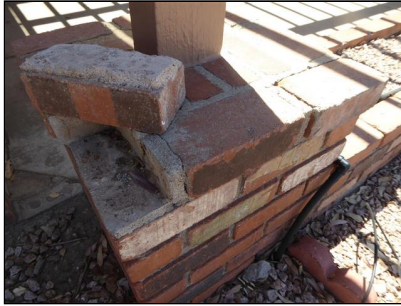
- »» (1) Brick work is separating from decorative bases that support front porch columns. Recommend re-cementing loose bricks to avoid further damage.

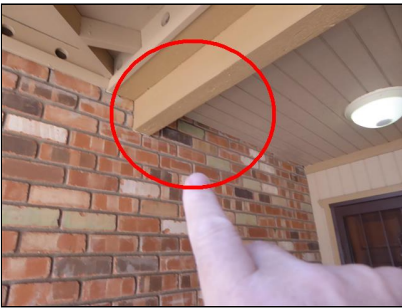
- »» (2) Observed small flying pest nest under front porch. Recommend contacting a pest control company to remove and treat area.

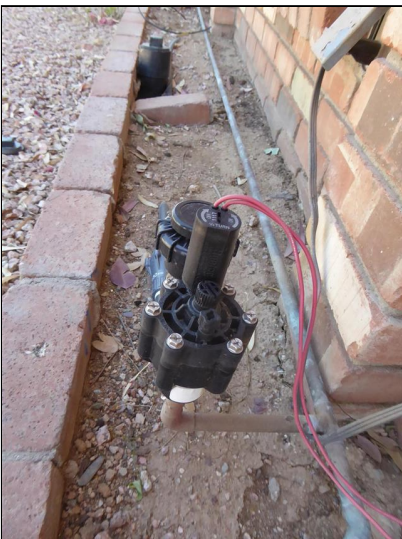
- » There are signs of an irrigation system present. Operation of the related equipment are not within the scope of this inspection. Recommend consulting sellers or landscape professional as to operation and condition of the irrigation system.

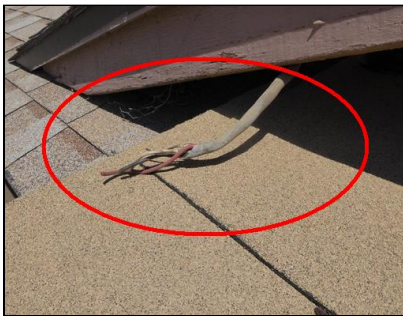
»» Observed an open electrical wire laying on east-side shed roof. This could be a safety hazard. Recommend review by qualified electrician.

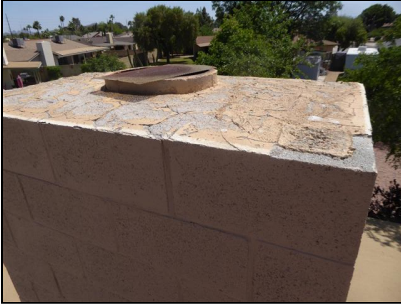
- »» Suggest sealing chimney cap (chimney crown) to reduce opportunity for water infiltration and damage. This is a common maintenance item that is often neglected by homeowners; you should make a crown inspection part of your routine seasonal maintenance checklist.

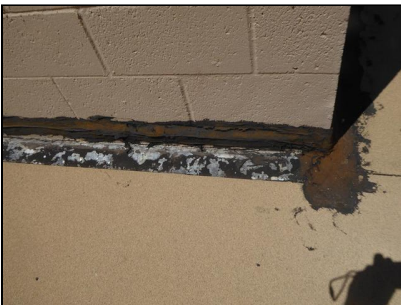
- »» The flashing located at the south-side of chimney should be resealed/re-secured to ensure leak free conditions.

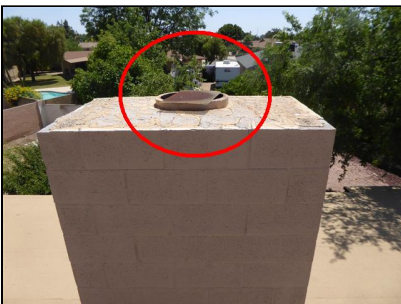
- »» No chimney rain cap observed, suggest installing a chimney rain cap to prevent the entrance of the elements, local wildlife, and to preserve the life of the chimney as well as minimize maintenance.

No spark arrester installed at chimney. Spark arresters may not have been required when house was built. Suggest client consider installing a spark arrester to enhance fire safety.

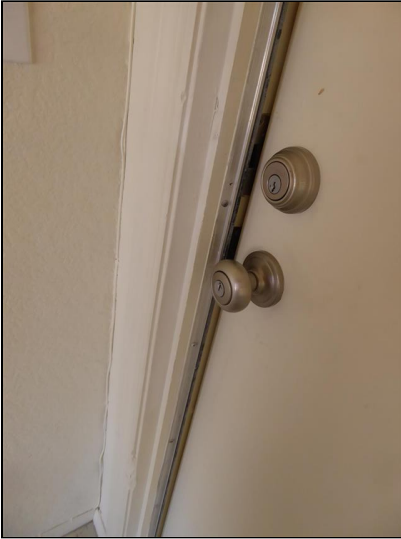
- The self-closing device or door hardware needs adjustment or repair to properly close completely and maintain the intended fire safety of this door.

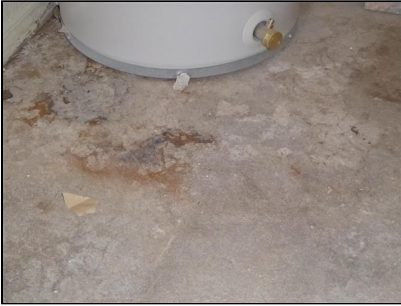
- Observed evidence of past water corrosion on floor around water heater. No active water leak was observed at time of inspection. This may have been from an old situation and is purely cosmetic at this point.

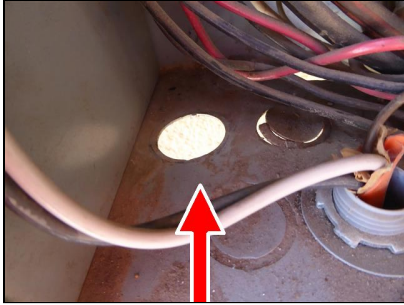
»» Open knockouts observed in the main panel cover; suggest installing knockout plugs, as needed, for safety.

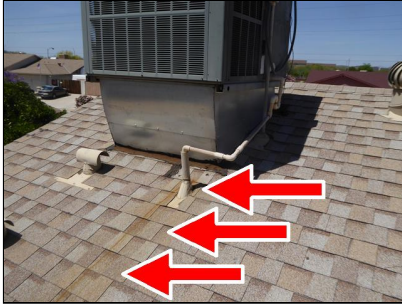
Unit 2 - Condensation Leak

- Observed signs of condensation access line leaking along roof at Unit 2. Recommend rerouting the units condensation line to go across roof, the same way Unit 1 condensation line runs.

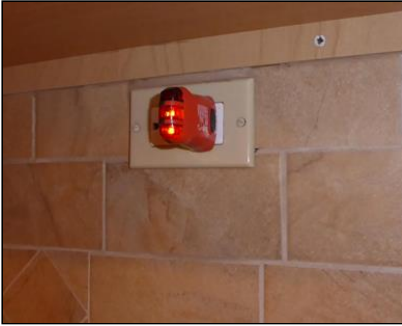
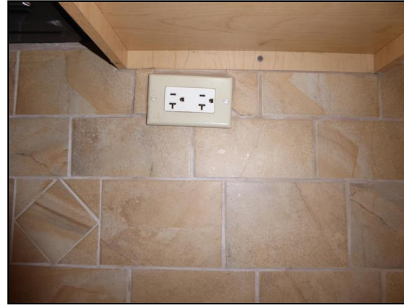
»» Ground Fault Circuit Interrupter (GFCI) outlets are not present, This should have been completed at the time the kitchen was remodeled. Suggest having a qualified electrician install GFCI for safety.

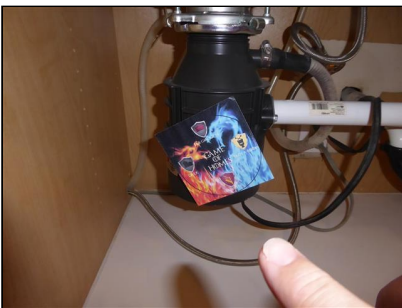
»» Garbage disposal is noisy; recommend review for corrections as needed.

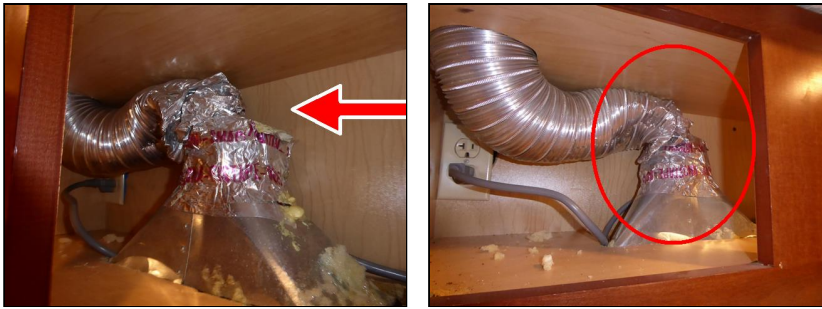
» Exhaust fan is noisy. Recommend review by qualified professional for repair or replacement as necessary.

Exhaust vent flue is damaged. Recommend repair to ensure appropriate air flow.

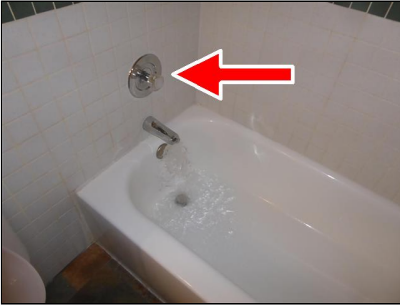
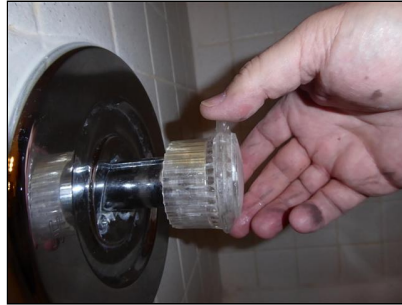
»» The hall bathroom faucet is damaged. It will pull out for water flow, but turning for hot and cold doesn't engage. Recommend review and repair as necessary, prior to close.

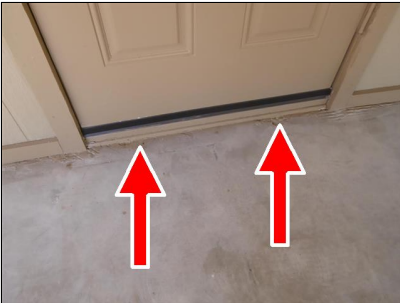
- Observed that air flow in to the laundry room is excessive and makes a high pitched noise of air escaping under door. Recommend shutting air damper vents to divert air flow to the general living areas.

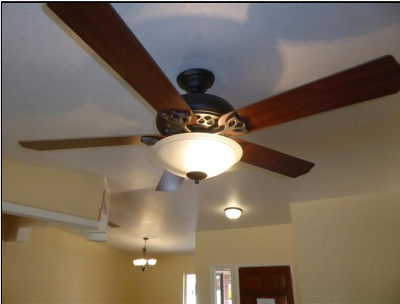
»» The ceiling fan in the living room is inoperable. Recommend review for corrections as needed.

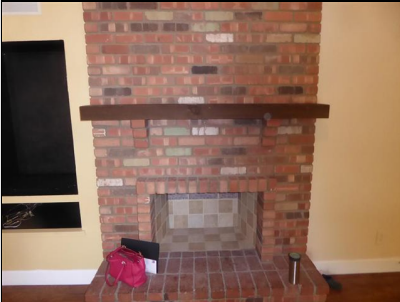
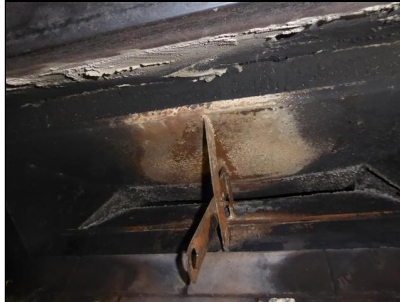
» Creosote build-up was observed in the fireplace located in the living room. Creosote is a naturally produced flammable by-product of combustion. Its presence is a limiting factor on a visual review. We suggest having cleaned and inspected by a fireplace and chimney specialist to assure safe operation prior to close.

The fireplace has new tile installed inside the box. There is no past evidence of the fireplace being used and no fire screen installed. It is not apparent that this is an operatable fireplace. Recommend having the unit reviewed by a qualified professional.

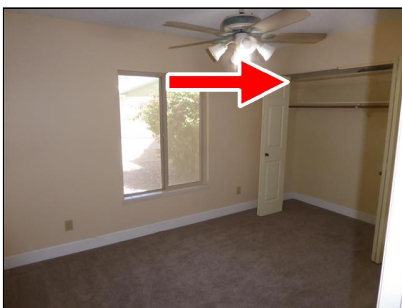
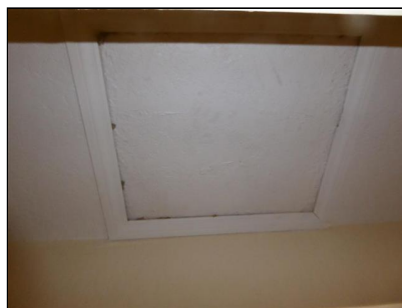
➤ Observed very small scuttle hole in center-right bedroom closet. Unable to access due to small size and blocked by a shelf. This area of attic was not inspected.

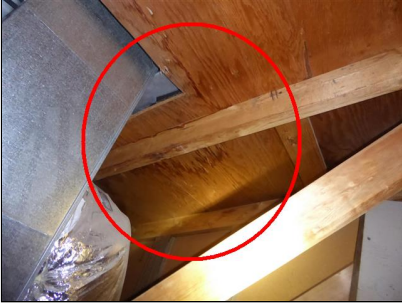
- Water staining observed on roof sheathing near entry point of Unit 2 HVAC duct. The inspector probed stains with a moisture detector, which showed no moisture present at time of inspection. Client is advised to consult seller to determine the source of staining and verify that corrections have been made.

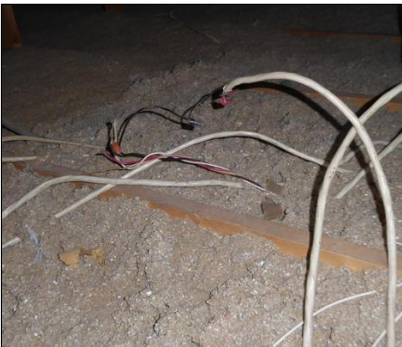
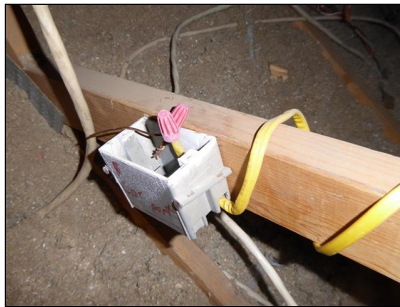
- Exposed electrical wires observed in the attic. This is a safety concern if used where it could be subject to physical damage. Exposed electrical wires are normally encased in a covered junction box to prevent damage. Recommend review by licensed electrician for removal or encasing in a covered junction box for safety.
