Inspection Report

3581 S Arizona Pl
Chandler AZ 85286

AmeriSpec Inspection Services

Date: [REDACTED]	Start Time: 08:00:00 AM Stop Time: 10:30 AM	Report ID: 060120RE14
Property: 3581 S Arizona Pl Chandler AZ 85286	Customer: [REDACTED]	Real Estate Professional: Vaught Team

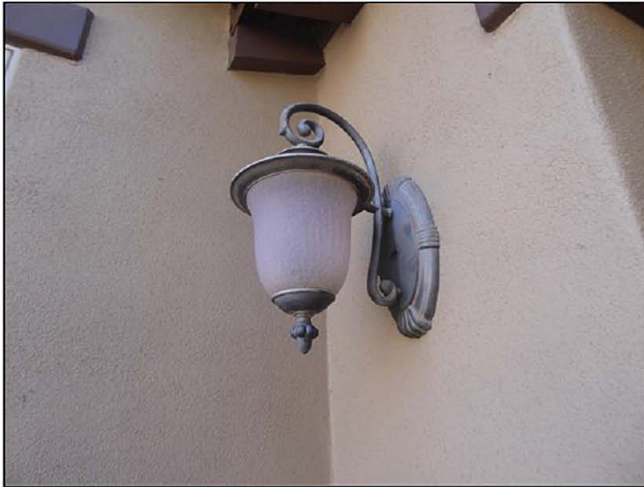
Left of garage

- Light fixture at front and rear of home is inoperative at time of inspection. Possible spent bulb or other sensor control. Suggest client verify fixture for proper operation.

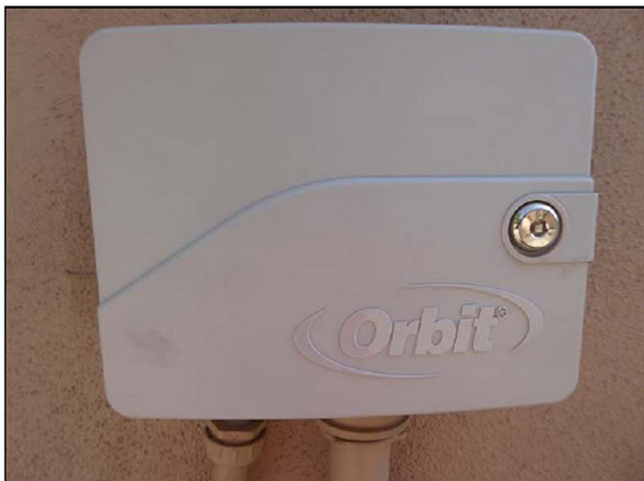
- There are signs of an irrigation system present. Operation of the related equipment are not within the scope of this inspection. Recommend consulting sellers or landscape professional as to operation and condition of the irrigation system.

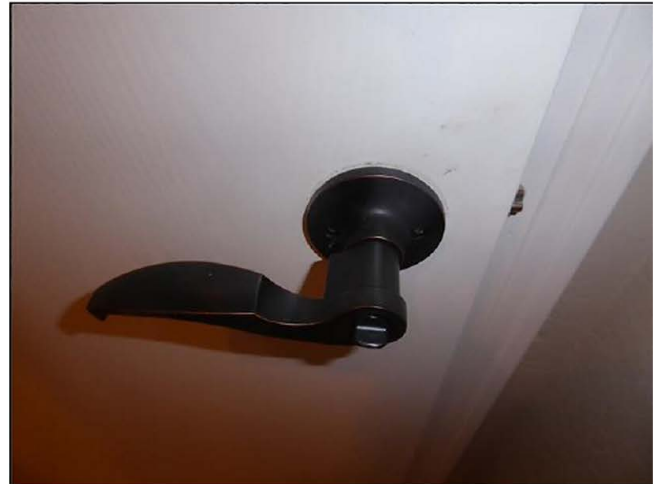
- »» The self-closing device or door hardware needs adjustment or repair to properly close completely and maintain the intended fire safety of this door.

Door does not latch properly, adjustments or repairs are needed.

Door not latching

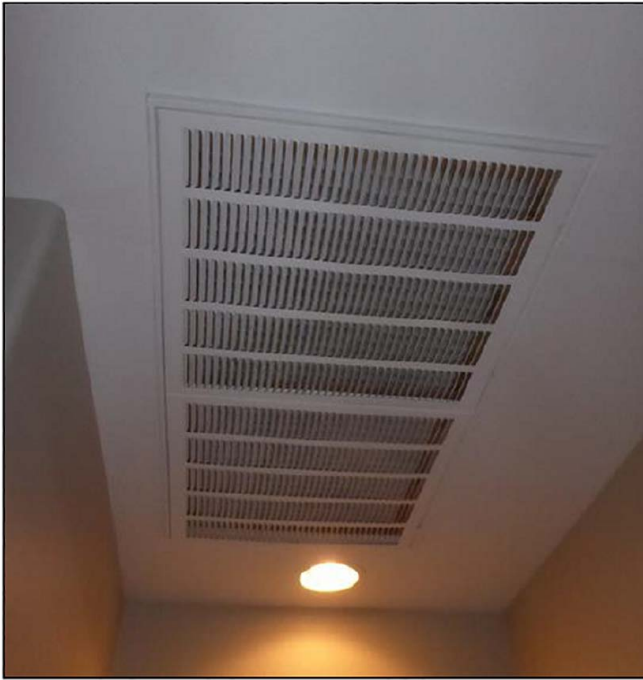
- We recommend cleaning/replacing the furnace/AC filter on a regular basis to optimize the unit's operating efficiency and life expectancy. We recommend that the client commence an annual maintenance, cleaning, and parts replacement program with the local utility company or qualified heating contractor in order to keep the heating/cooling equipment in optimum and safe working order.

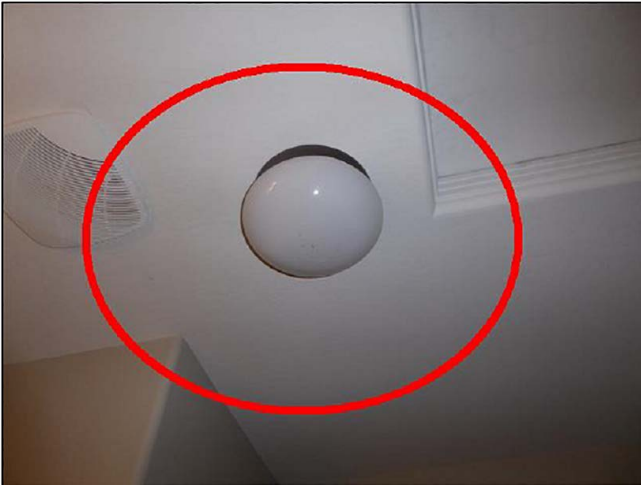
- Light fixture in the 2nd floor hall bathroom was inoperative at time of inspection. Possible spent bulb. Suggest client verify fixture for proper operation prior to closing.

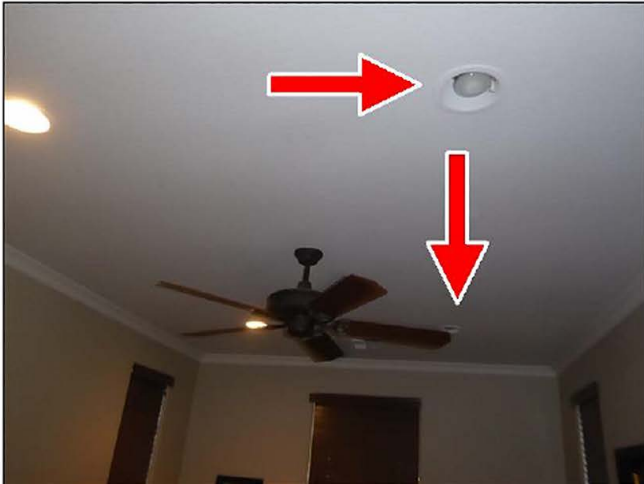
Office Room

- Light fixtures in the office room and 2nd floor bonus room were inoperative at time of inspection. Possible spent bulb. Suggest client verify fixture for proper operation.

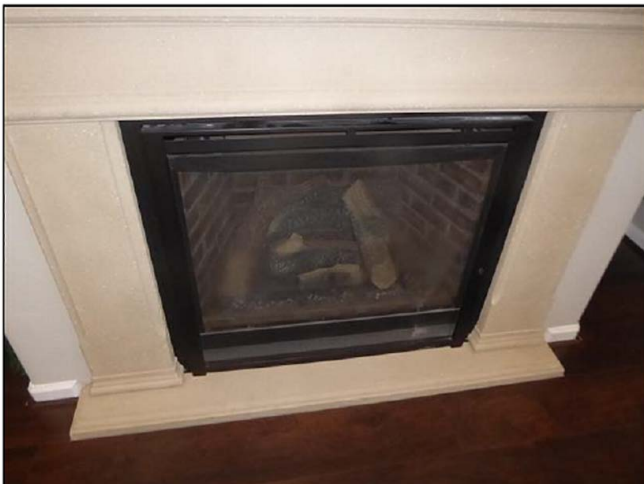
Gas logs are present. We recommend using caution when gas logs are used in this fireplace. Always operate per manufactures recommendations and with damper open to allow products of combustion to vent to exterior. Client may wish to consider installing a damper stop for safety if one is not already present.

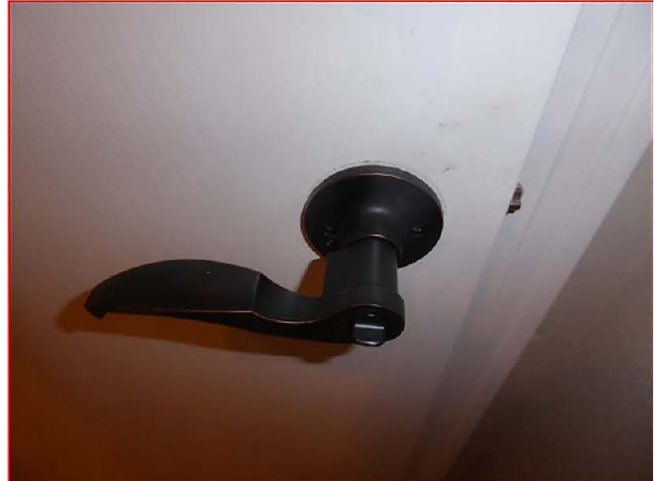
Door not latching

- »» The self-closing device or door hardware needs adjustment or repair to properly close completely and maintain the intended fire safety of this door.

Door does not latch properly, adjustments or repairs are needed.

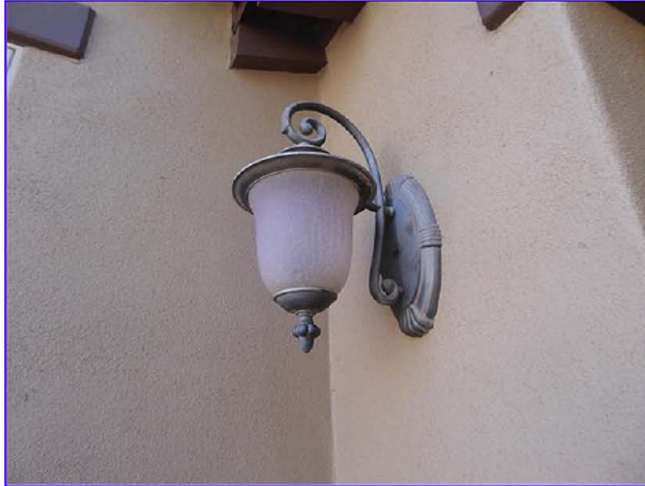
Left of garage

- Light fixture at front and rear of home is inoperative at time of inspection. Possible spent bulb or other sensor control. Suggest client verify fixture for proper operation.

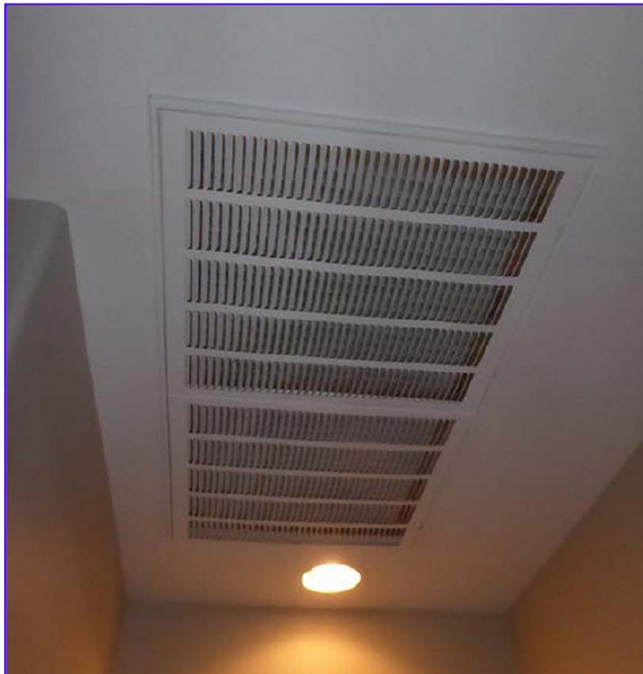
- We recommend cleaning/replacing the furnace/AC filter on a regular basis to optimize the unit's operating efficiency and life expectancy. We recommend that the client commence an annual maintenance, cleaning, and parts replacement program with the local utility company or qualified heating contractor in order to keep the heating/cooling equipment in optimum and safe working order.

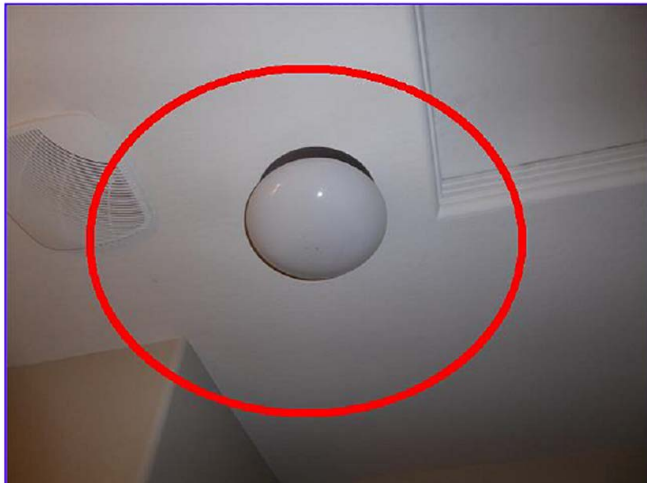
- Light fixture in the 2nd floor hall bathroom was inoperative at time of inspection. Possible spent bulb. Suggest client verify fixture for proper operation prior to closing.

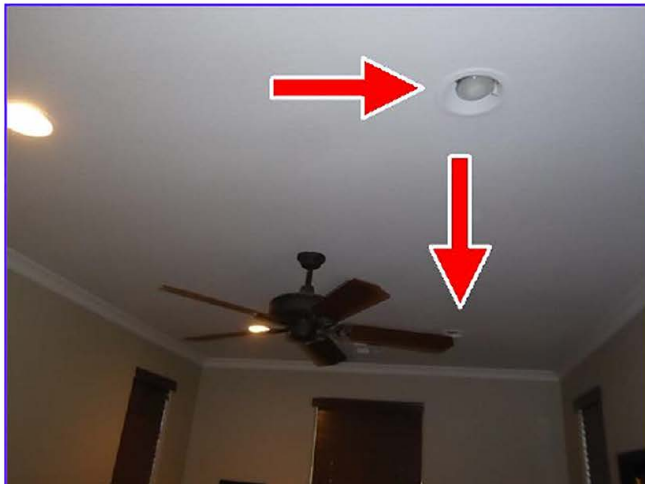
Office Room

- Light fixtures in the office room and 2nd floor bonus room were inoperative at time of inspection. Possible spent bulb. Suggest client verify fixture for proper operation.
