Inspection Report

Sample Report - Older Home

AmeriSpec Inspection Services

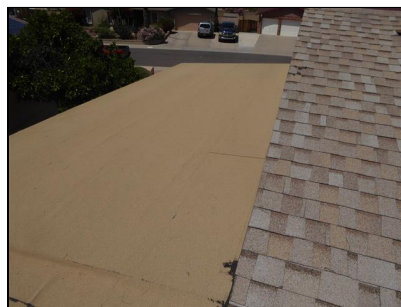
West Shed Roofing

- »» (1) Inspected two built on shed areas on each side of home. These units are built on or next to the property's block fencing. Observed several cracked roofing rafters in both units. Roof sheathing is warped, broken or missing in several areas on both units. Recommend review and repair by professional, as needed.

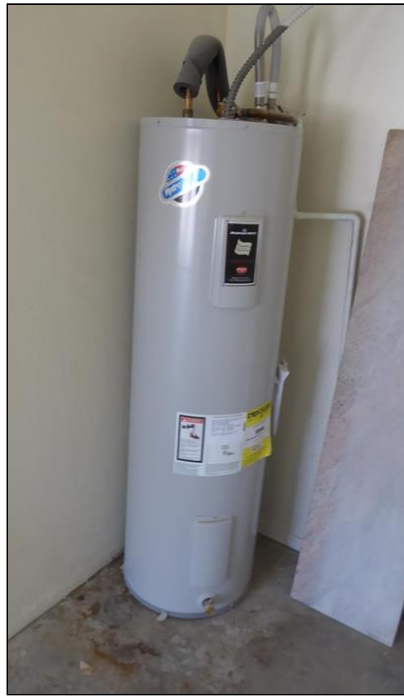
Water Heater

- Observed evidence of past water corrosion on floor around water heater. No active water leak was observed at time of inspection. This may have been from an old situation and is purely cosmetic at this point.

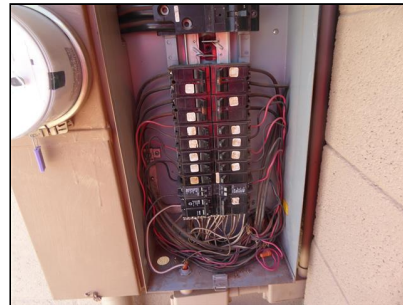
Main electrical panel with dead front removed

»» Open knockouts observed in the main panel cover; suggest installing knockout plugs, as needed, for safety.

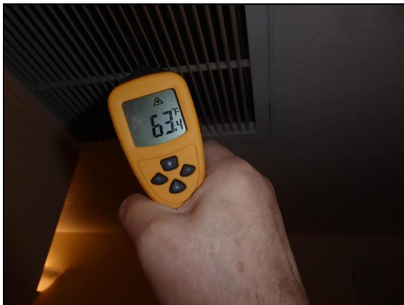
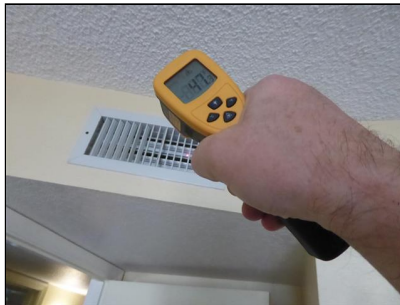
(1) A temperature drop was performed across the evaporator coil of this unit. When tested, temperature at return register was 63 degrees, temperature at supply was 47 degrees, a difference of 16 degrees which is in the 14 to 22 degree normal operating range. Unit functioned properly when tested and was serviceable at time of inspection.

Unit 1 - Return Air Temp

Unit 1 - Supply Air Temp

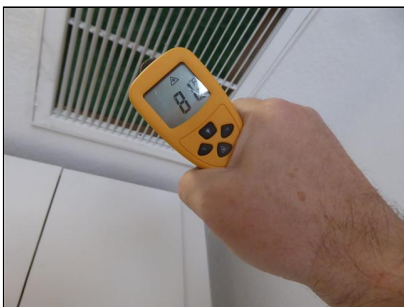
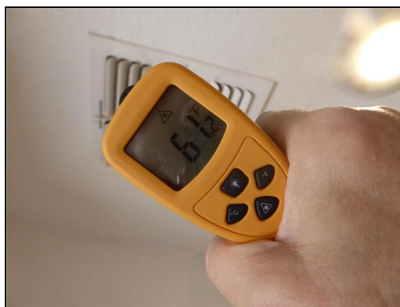
(2) A temperature drop was performed across the evaporator coil of this unit. When tested, temperature at return register was 81 degrees, temperature at supply was 61 degrees, a difference of 20 degrees which is in the 14 to 22 degree normal operating range. Unit functioned properly when tested and was serviceable at time of inspection.

Unit 2 - Return Air Temp

Unit 2 - Supply Air Temp

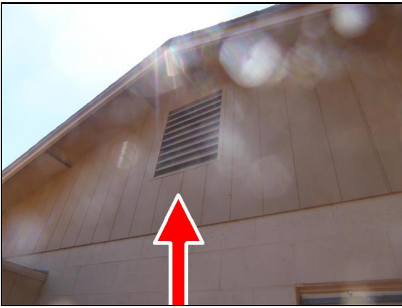
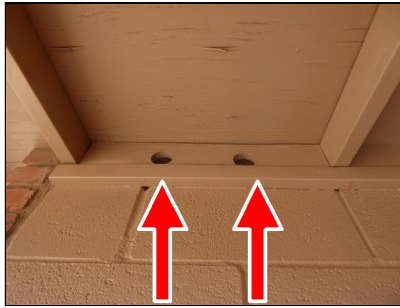
Adequate ventilation was noted.

Gable Vent

Soffit Vents
